Engineering Bulletin Simplified Aircraft/Engine Repair (EB-SR)

EB-SR-No. 00161964/001

Elongated Fastener Holes at the LH Underwing Fixed Panel Seal Retainer and Retainer Angle

Product / (A/C type or Engine type) A320 / A320-214	ATA 57-51-37	OEM-Reference (e.g. SB, AMM, EM, CMM, IPC) DLH AMM [Rev.113 MAY 01/2019]
---	------------------------	--

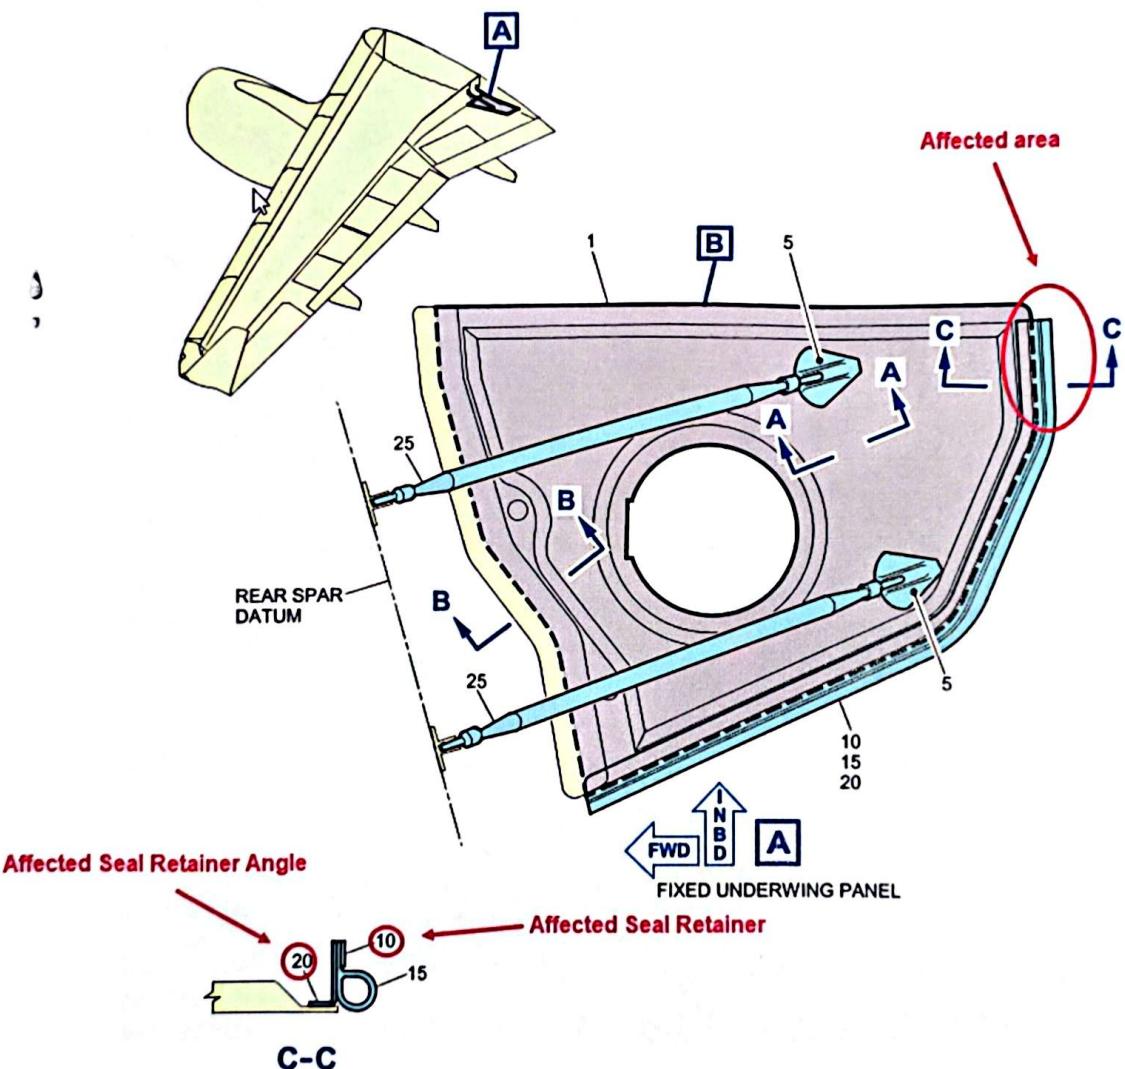
During maintenance work in zone 571 on the fixed under wing panel one fastener hole at the seal retainer and seal retainer angle was found elongated.

For location and details refer to sketches below:

1. Remove the seal retainer PN D5754125820200.
2. Perform a detailed visual inspection to ensure that no additional damage is present in the affected area.
3. If required perform a cleanup of the affected fastener hole at the seal retainer angle.
4. Install a new seal retainer PN D5754125820200.
5. Install the affected seal part as per AMM requirements. Use the original fastener type and install washer PN AN970-3 on seal retainer angle side.
Make sure that the thread from the fastener is minimum 3 turns visible. If required adapt the grip length of the fastener.
6. Open a deferred Item index O for re-inspections every 250FH to ensure good condition of the performed repair.
7. Open a deferred item for replacement of the seal retainer angle PN D5754125820000 within 500FH.
