## SERVICE INFORMATIONAL LETTER

**SL 2019-32-004**

**SUBJECT:** Radial Tire Sidewall Undulations

**USED ON:** Aircraft Using Goodyear Radial Tires

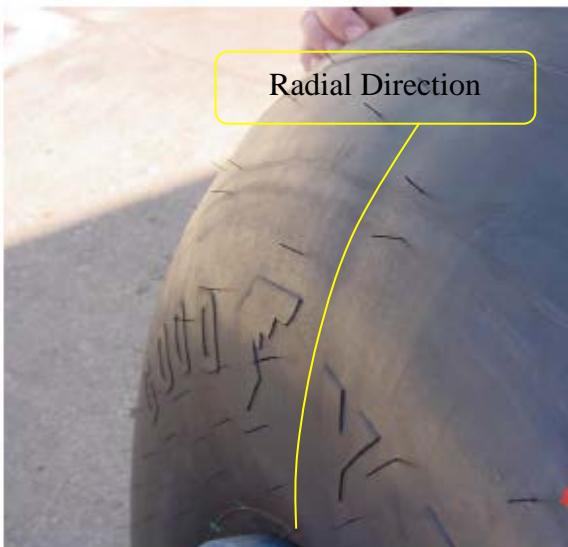
Sidewall Undulation

Radial aircraft tires are assembled with plies (layers) of rubber-coated nylon cords, which are oriented in a radial direction from bead to bead. The plies are held together during assembly by overlapping the ends. This can result in minor sidewall undulations, or protrusions, which are normal for radial tire construction. Visible sidewall undulations do not present safety or performance issues in continued service in accordance with the removal criteria stated below.

**REMOVAL CRITERIA FOR SIDEWALL UNDULATION:** Any radial tire with a sidewall undulation (depth or height) of 3 mm (0.12") or less may remain in service. Remove from service any tire with a sidewall undulation which exceeds 3 mm in depth, or height, at next maintenance opportunity.
